POLO & ASSOCIATES HOME INSPECTIONS, LLC

David J. Polo Home Inspector Lic. #24GI00023700

*Survey Abstract (*Summary of Concerns*)

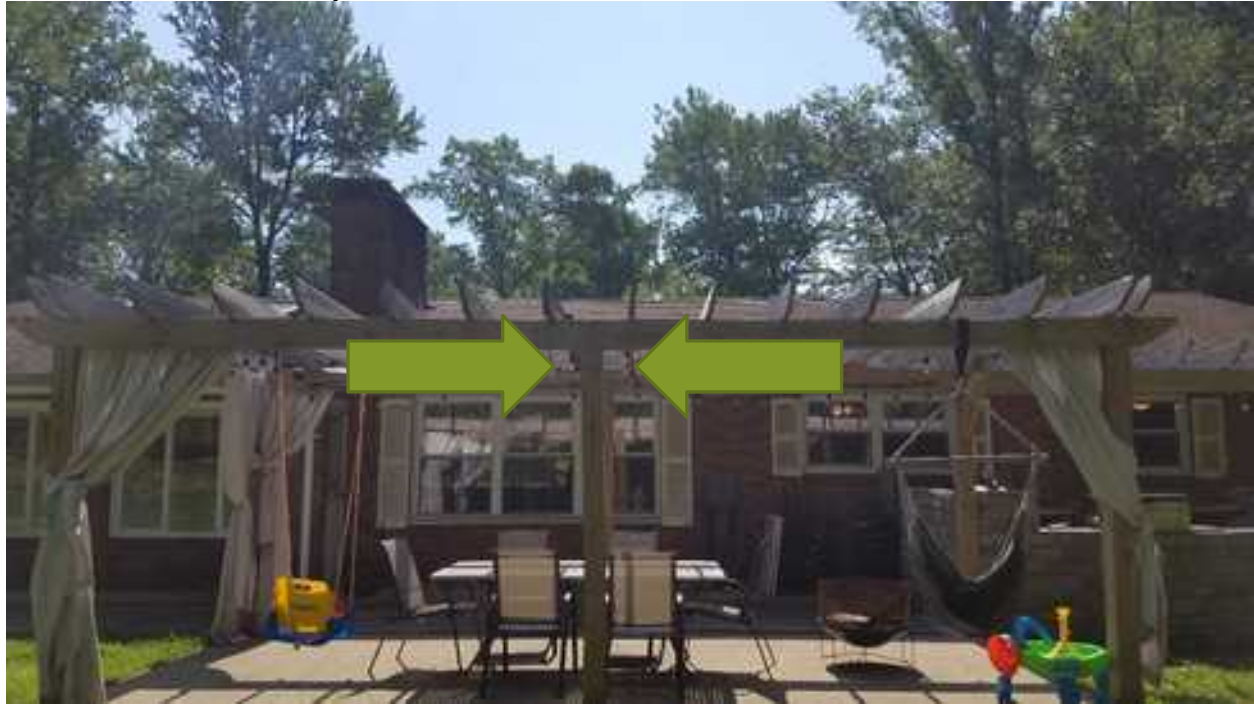
[1C.34](#) **Structural instability for trellis at the rear. Missing lateral bracing parallel to dwelling; columns not secured to ground/footings; wobbly. Repair is recommended for structural integrity and obtain permits from town to verify footings. This is a safety concern**

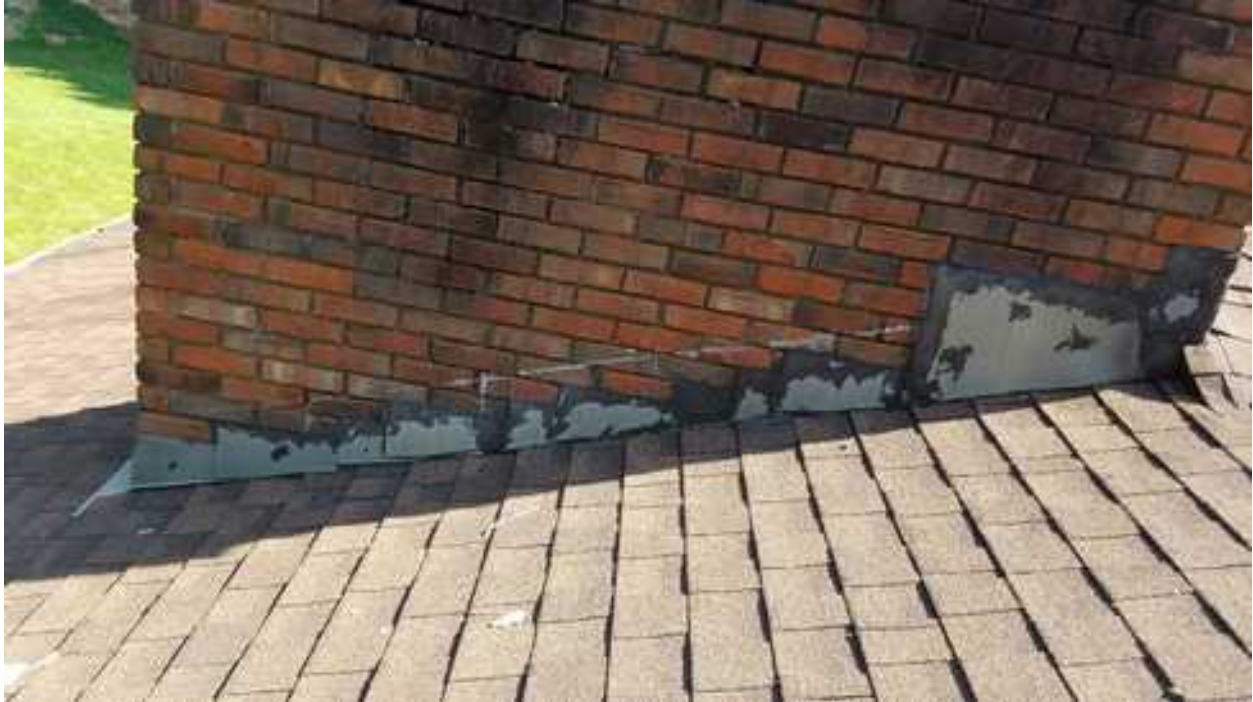
[1B.04](#) Chimney top is deteriorating/cracked/loose. Recommendation: Repair or replace to prevent water intrusion

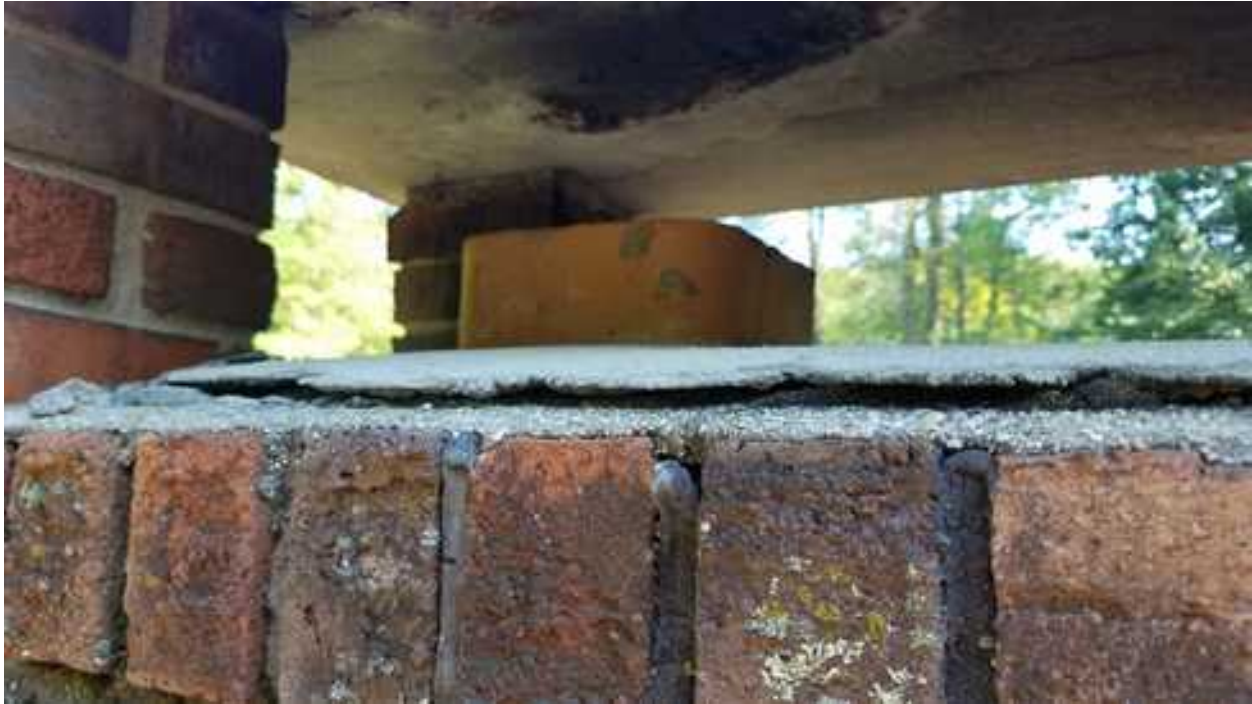
Mortar joints missing/deteriorating/loose for siding/chimney. Re-pointing needed for stability and to minimize infiltration

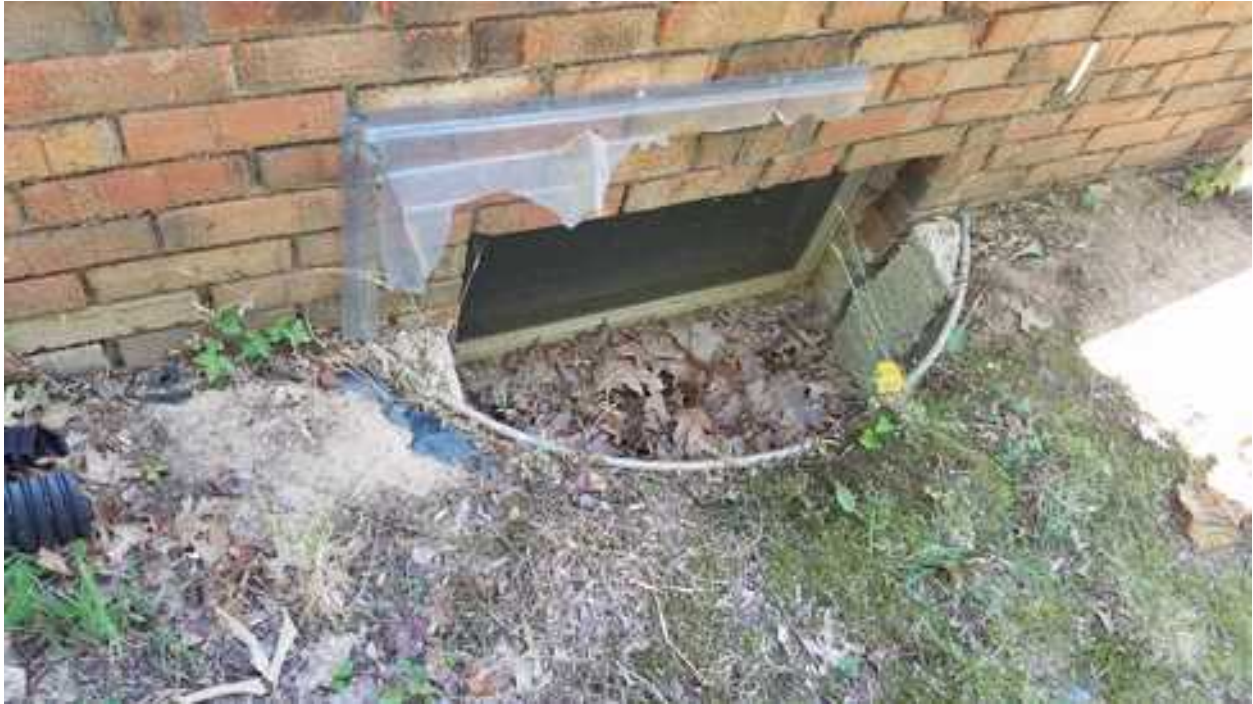
[2C.23](#) **Water penetration from exterior. Perform all recommended corrections to reduce water intrusion/damage and monitor if further repairs are needed**

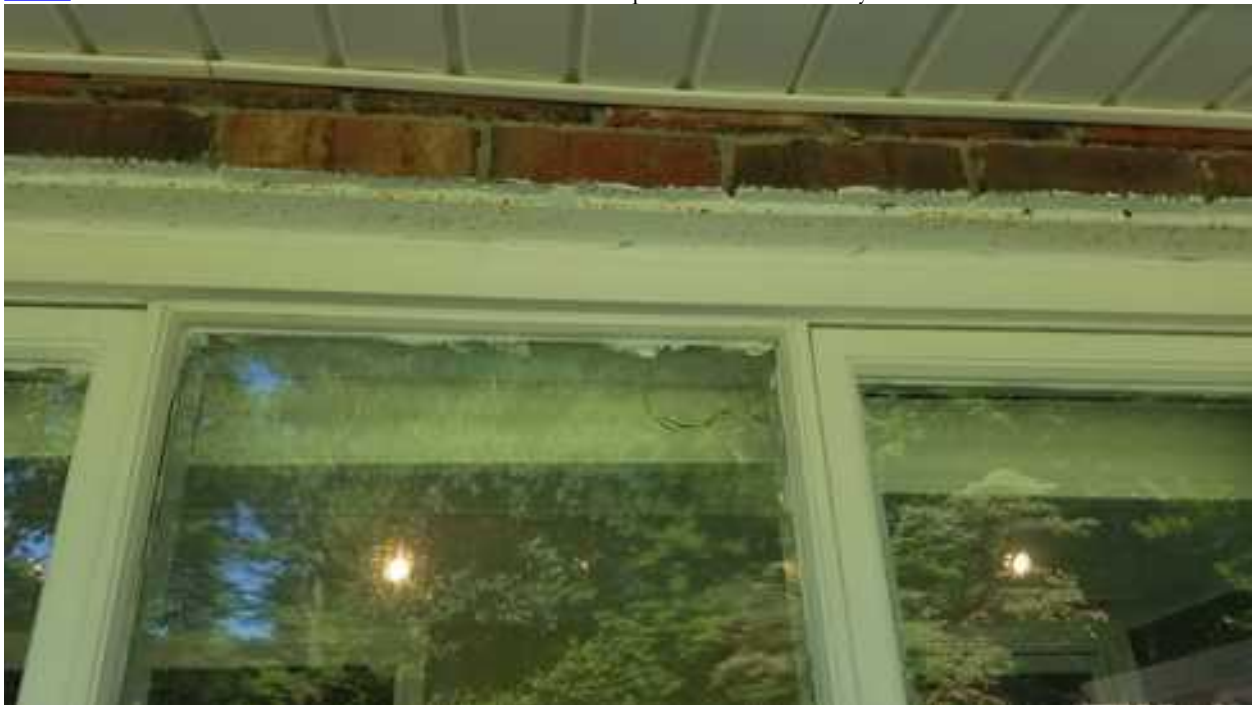
[2C.01](#) Glazing compound (window "putty") deteriorating. Recommendation: Repair or replace

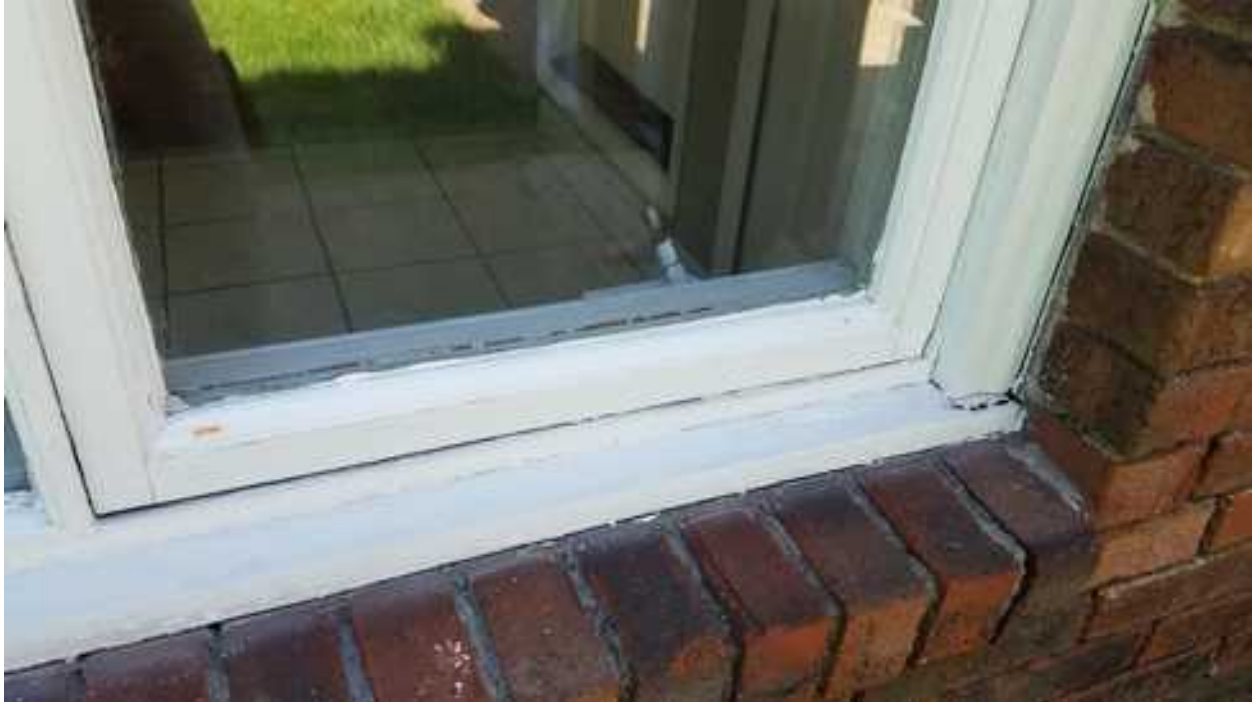
[1C.06](#) Wood rot; trim, casement windows. Recommendation: Repair or replace. This is a safety concern

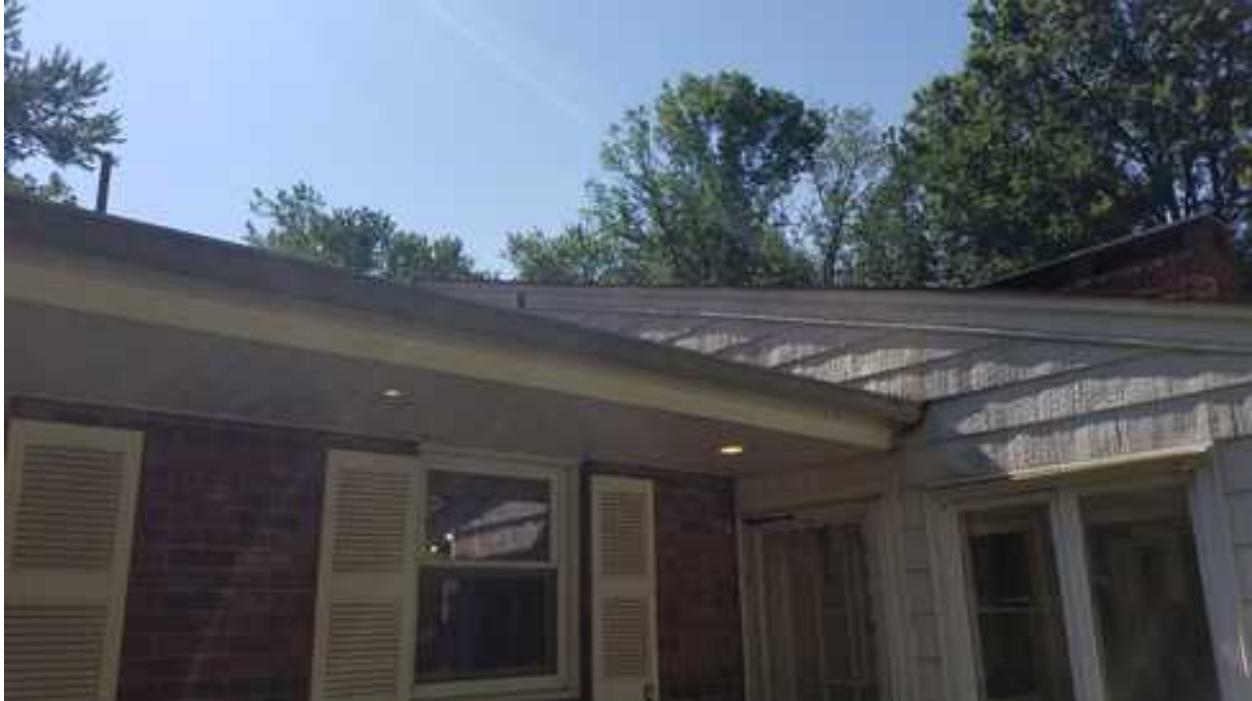
Commercial size gutters & downspouts are recommended (especially with steep pitches, valleys, etc.) to prevent heavy rains from caroming over gutters

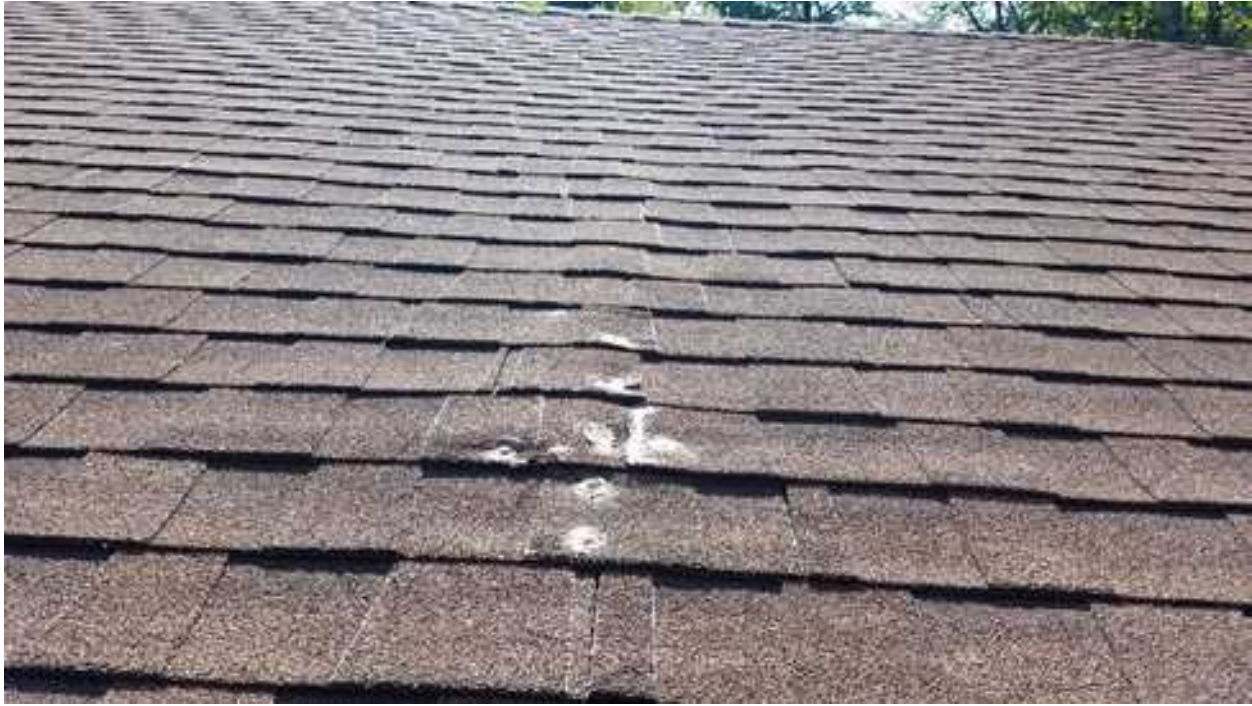
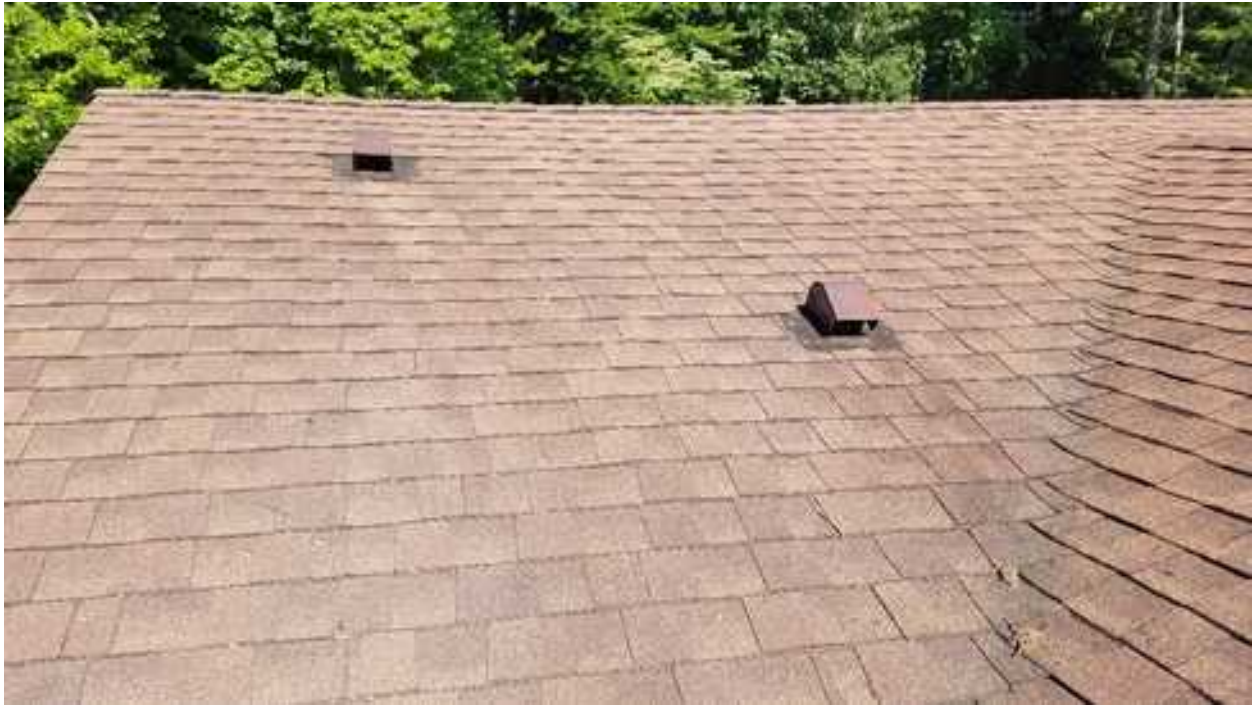
- [3C.03](#) Shingles, asphalt: eroded/pitted/granules missing is consistent with the aging process of an older roof. Recommendation: Monitor, repair and budget for future functionality
- Shingles, fiberglass mat exposed in areas will absorb water and leak. Recommendation: Replace
- [3C.01](#) Shingles, asphalt: separating from thermal expansion/excessive heat, age, lack of ventilation. Recommendation: Repair or replace to prevent leaking

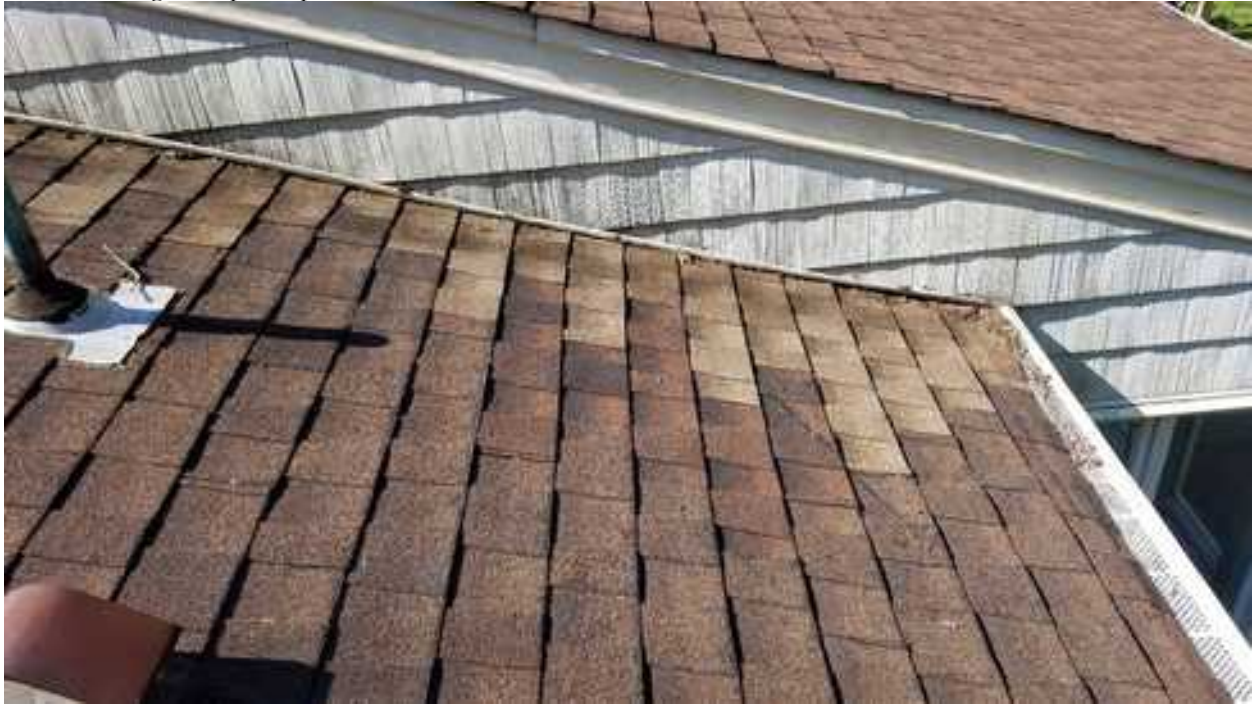
[3C.01](#) Shingles, broken/cracked/loose/lifting at the front and at the rear. Recommendation: Repair or replace to prevent leaking

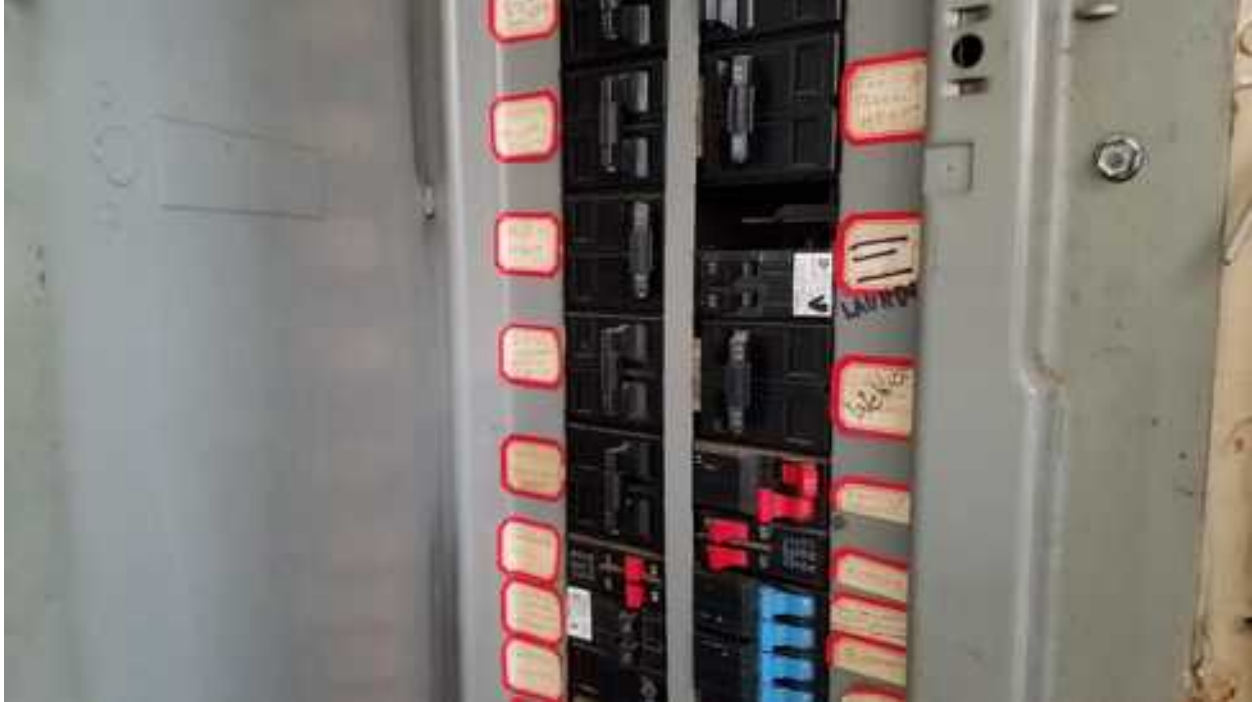
[5C.67](#) Labels and an accurate legend recommended for ALL panel/sub-panel box circuits. This is a safety concern

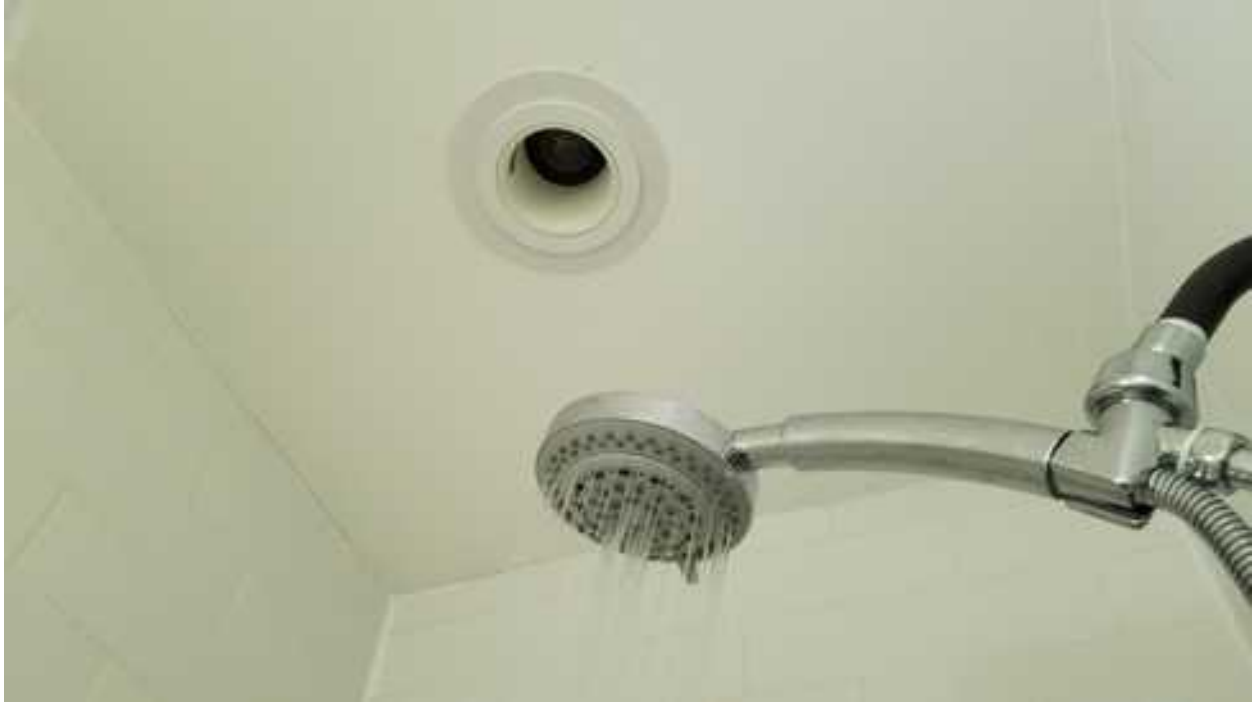
Recessed lighting does not appear to be IC rated (chrome finish not present) for material contact in the attic. Repair/replacement is recommended. This is a safety concern

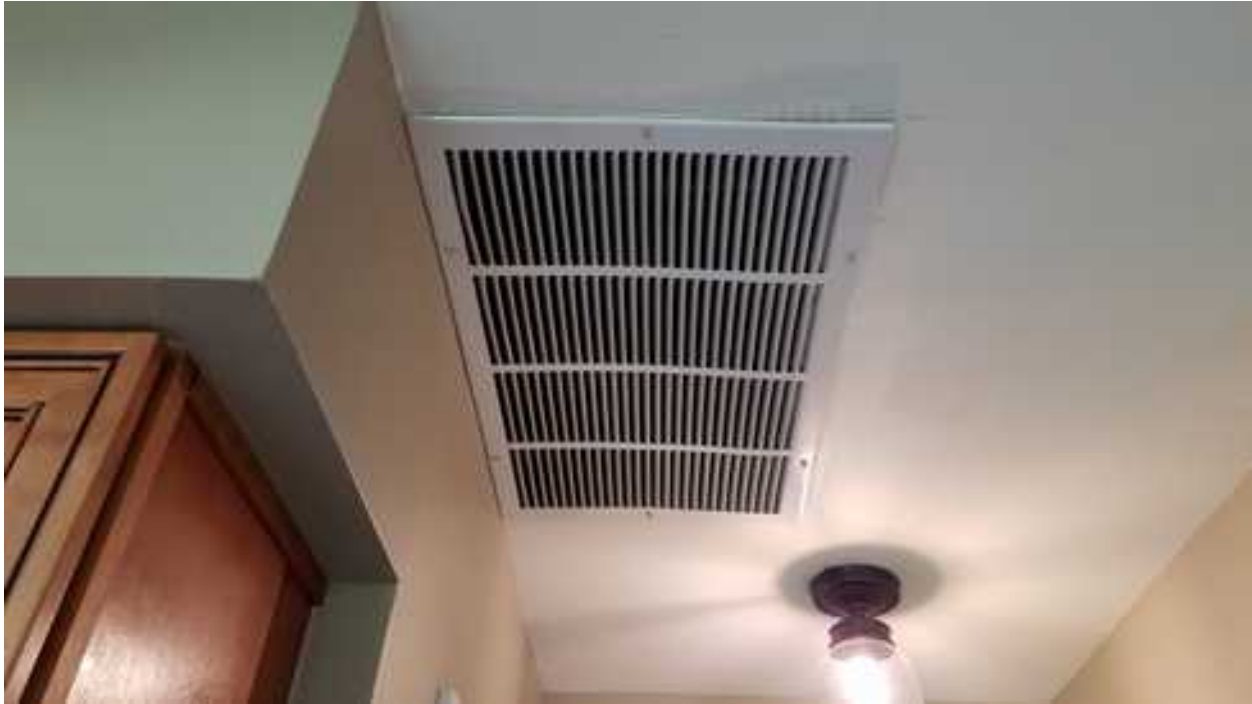
Ducts (especially returns) and blower compartment may be in need of a PROFESSIONAL cleaning to remove dust, dirt, construction debris, dust mites, etc. This is a health and efficiency concern

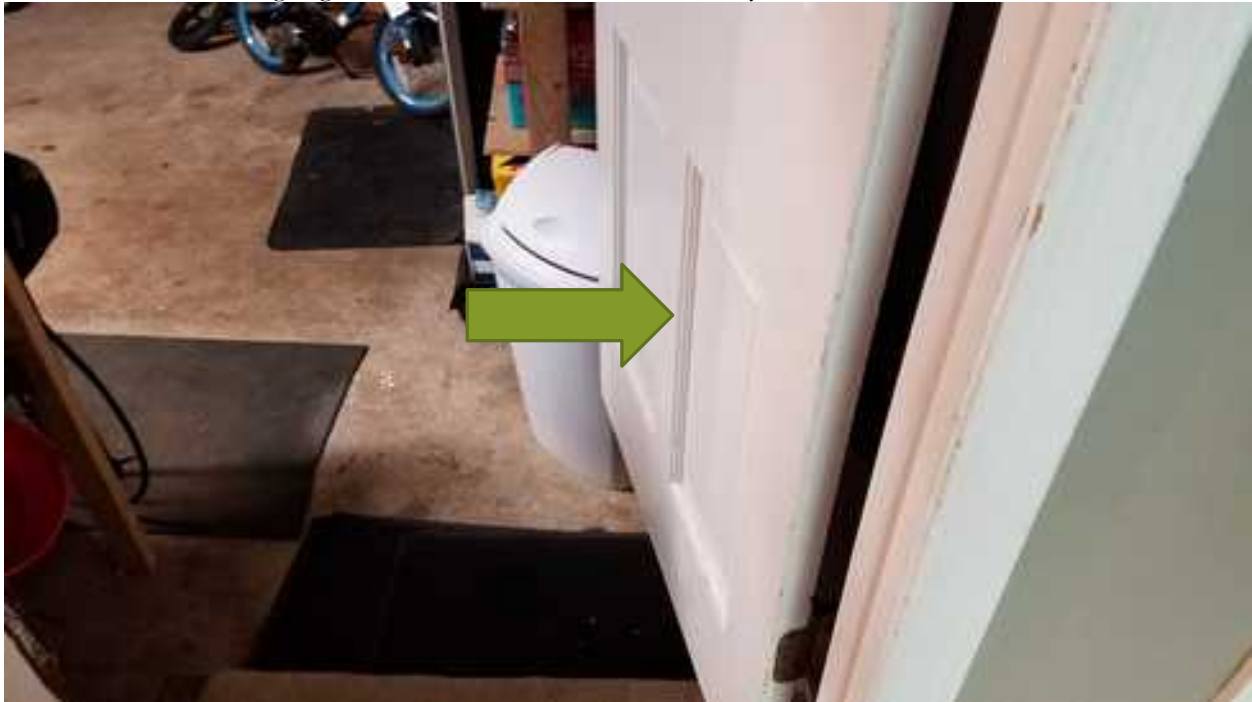
[3C.34](#) Fire resistant ceiling & walls with no openings are recommended in the garage for fire and C/O safety
