POLO & ASSOCIATES HOME INSPECTIONS, LLC

David J. Polo Home Inspector Lic. #24GI00023700

*Survey Abstract (*Summary of Concerns*)

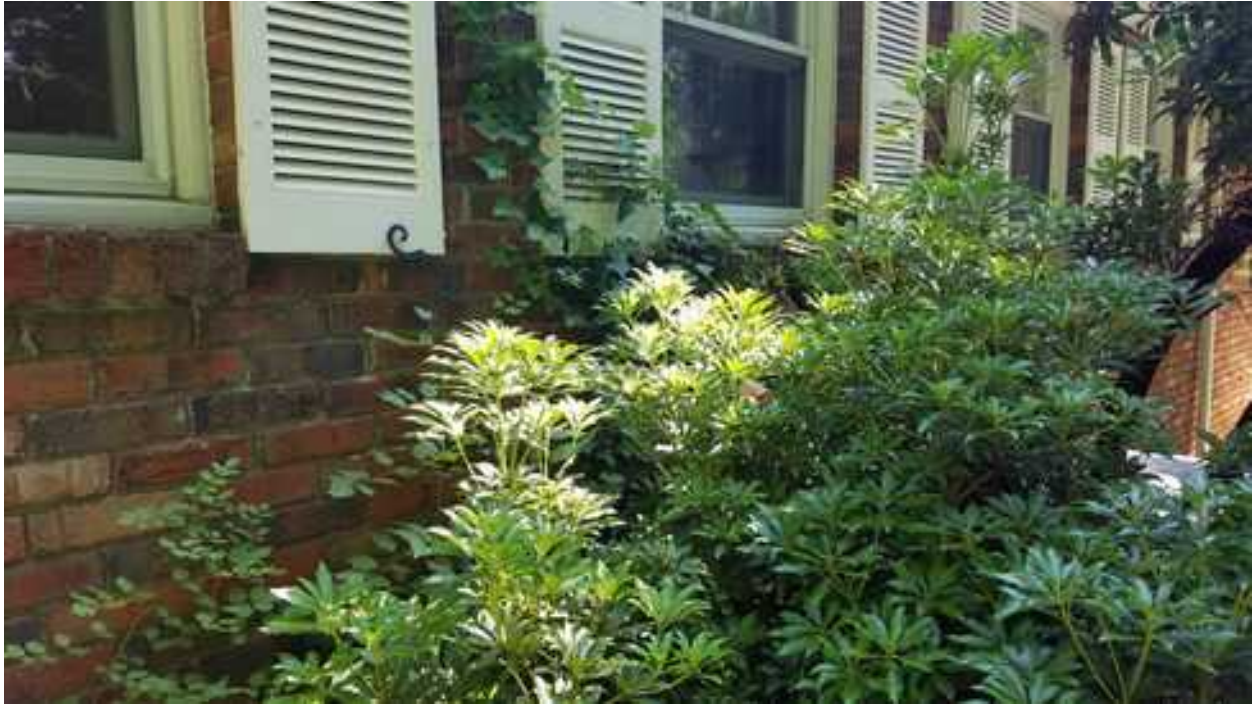
All "vegetation" with immediate detrimental effect on dwelling/garage should be fully assessed, managed and maintained for safety and proper function

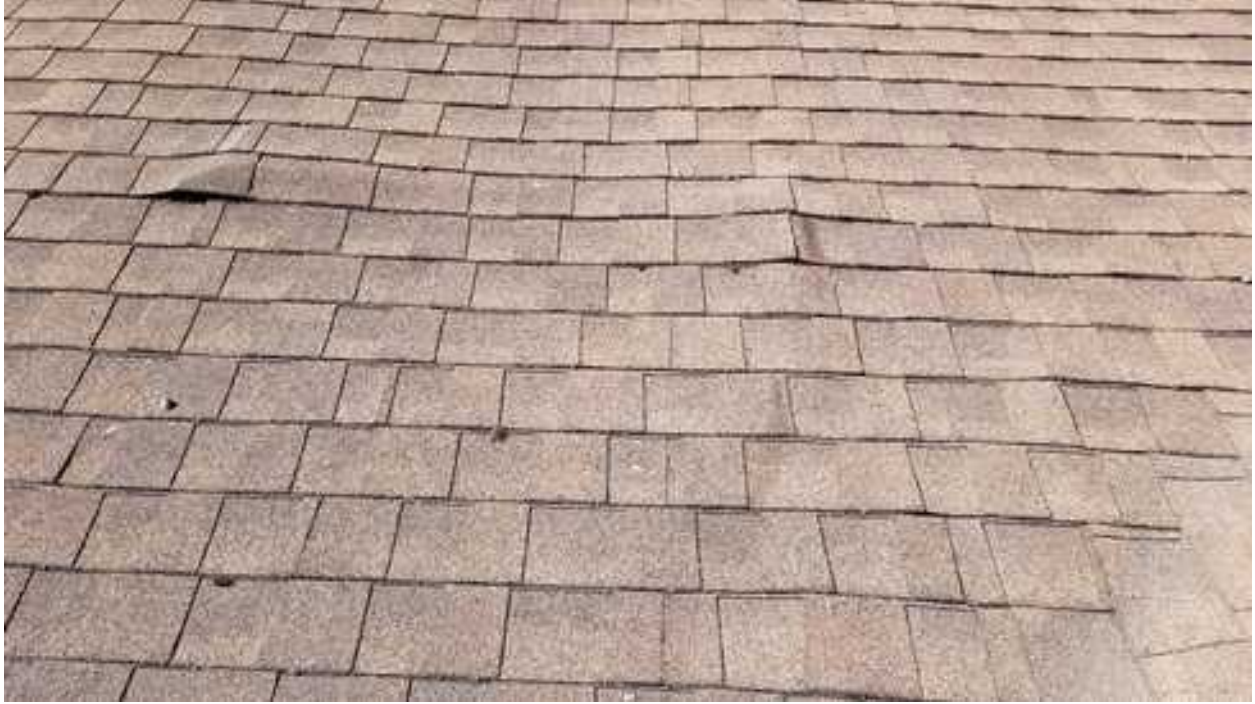
[3C.01](#) Shingles, broken/cracked/loose/lifting at the front and at the rear. Recommendation: Repair or replace to prevent leaking

[3A.20](#) Roof (not roof structure) comparative rating: apparently older
Repairs/replacement needed

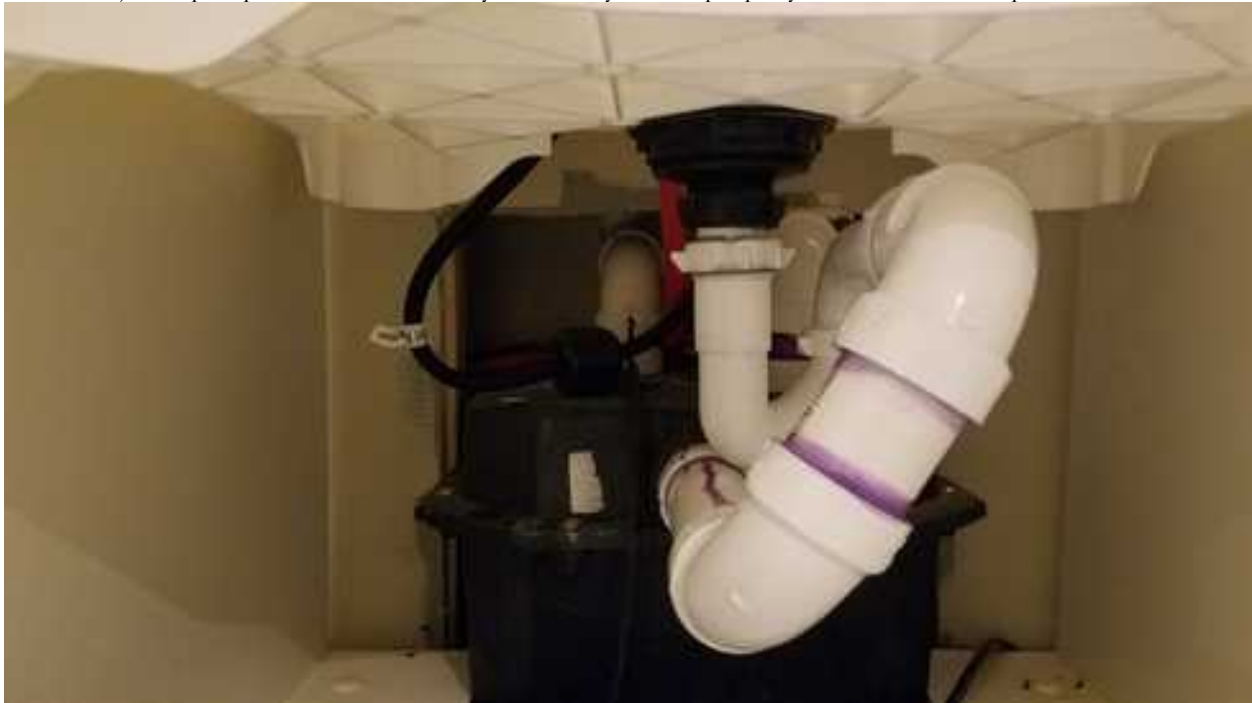
[4C.07](#) Ejector pump area odor in laundry room may not be properly vented/sealed. Repair is recommended

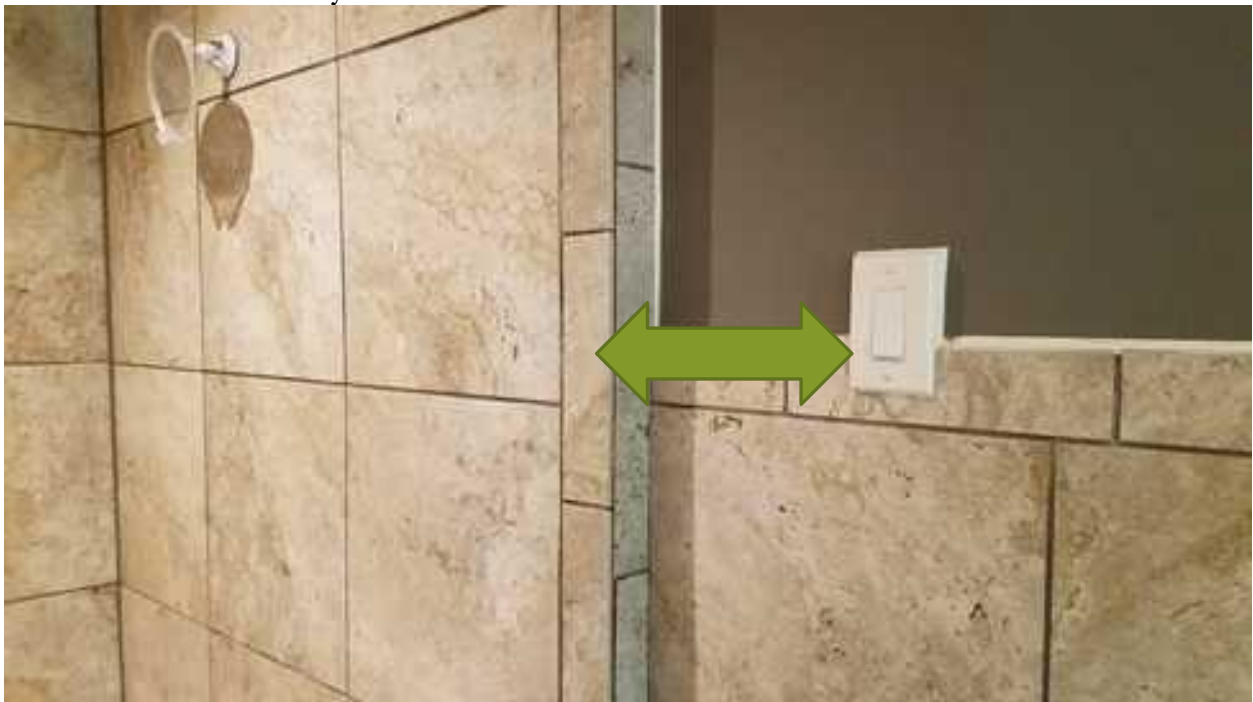
[5C.71](#) Switch to close (3' or less) to tub, shower. Move away/repair is recommended. This is a safety concern in the master bathroom

[5A.40](#) Electrical comparative rating: apparently poor

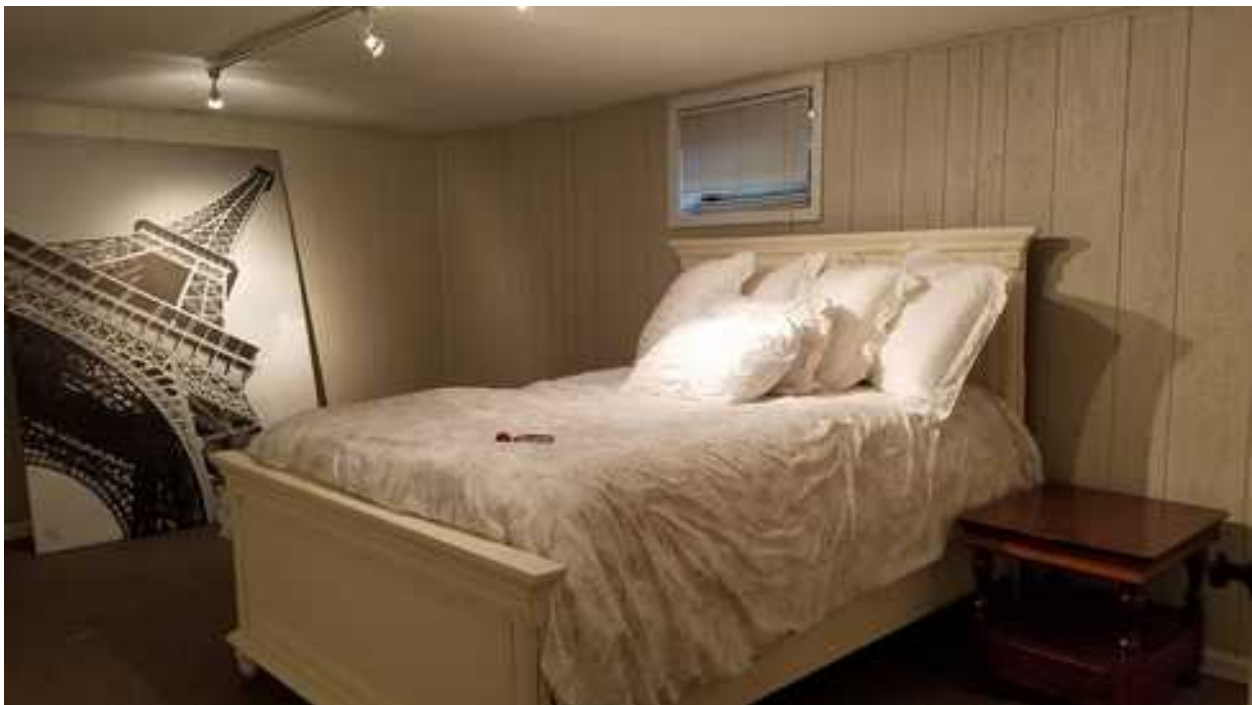
[7C.03](#) Window, bedroom: less than 4-sq. ft. operable, too high off floor etc. in the basement (egress concern). Repair is recommended. This is a safety concern. This is an expense concern

[7A.20](#) Interior comparative rating: apparently fair
Unprofessional or amateur workmanship is often a tell-tale sign of what may be present but not visible therefore may likely increase safety risk and budget
